THE GREAT ALASKA EARTHQUAKE

Volume II

Illustrations and Maps

TECHNICAL REPORT NO. AFWL-TR-65-92, Vol II

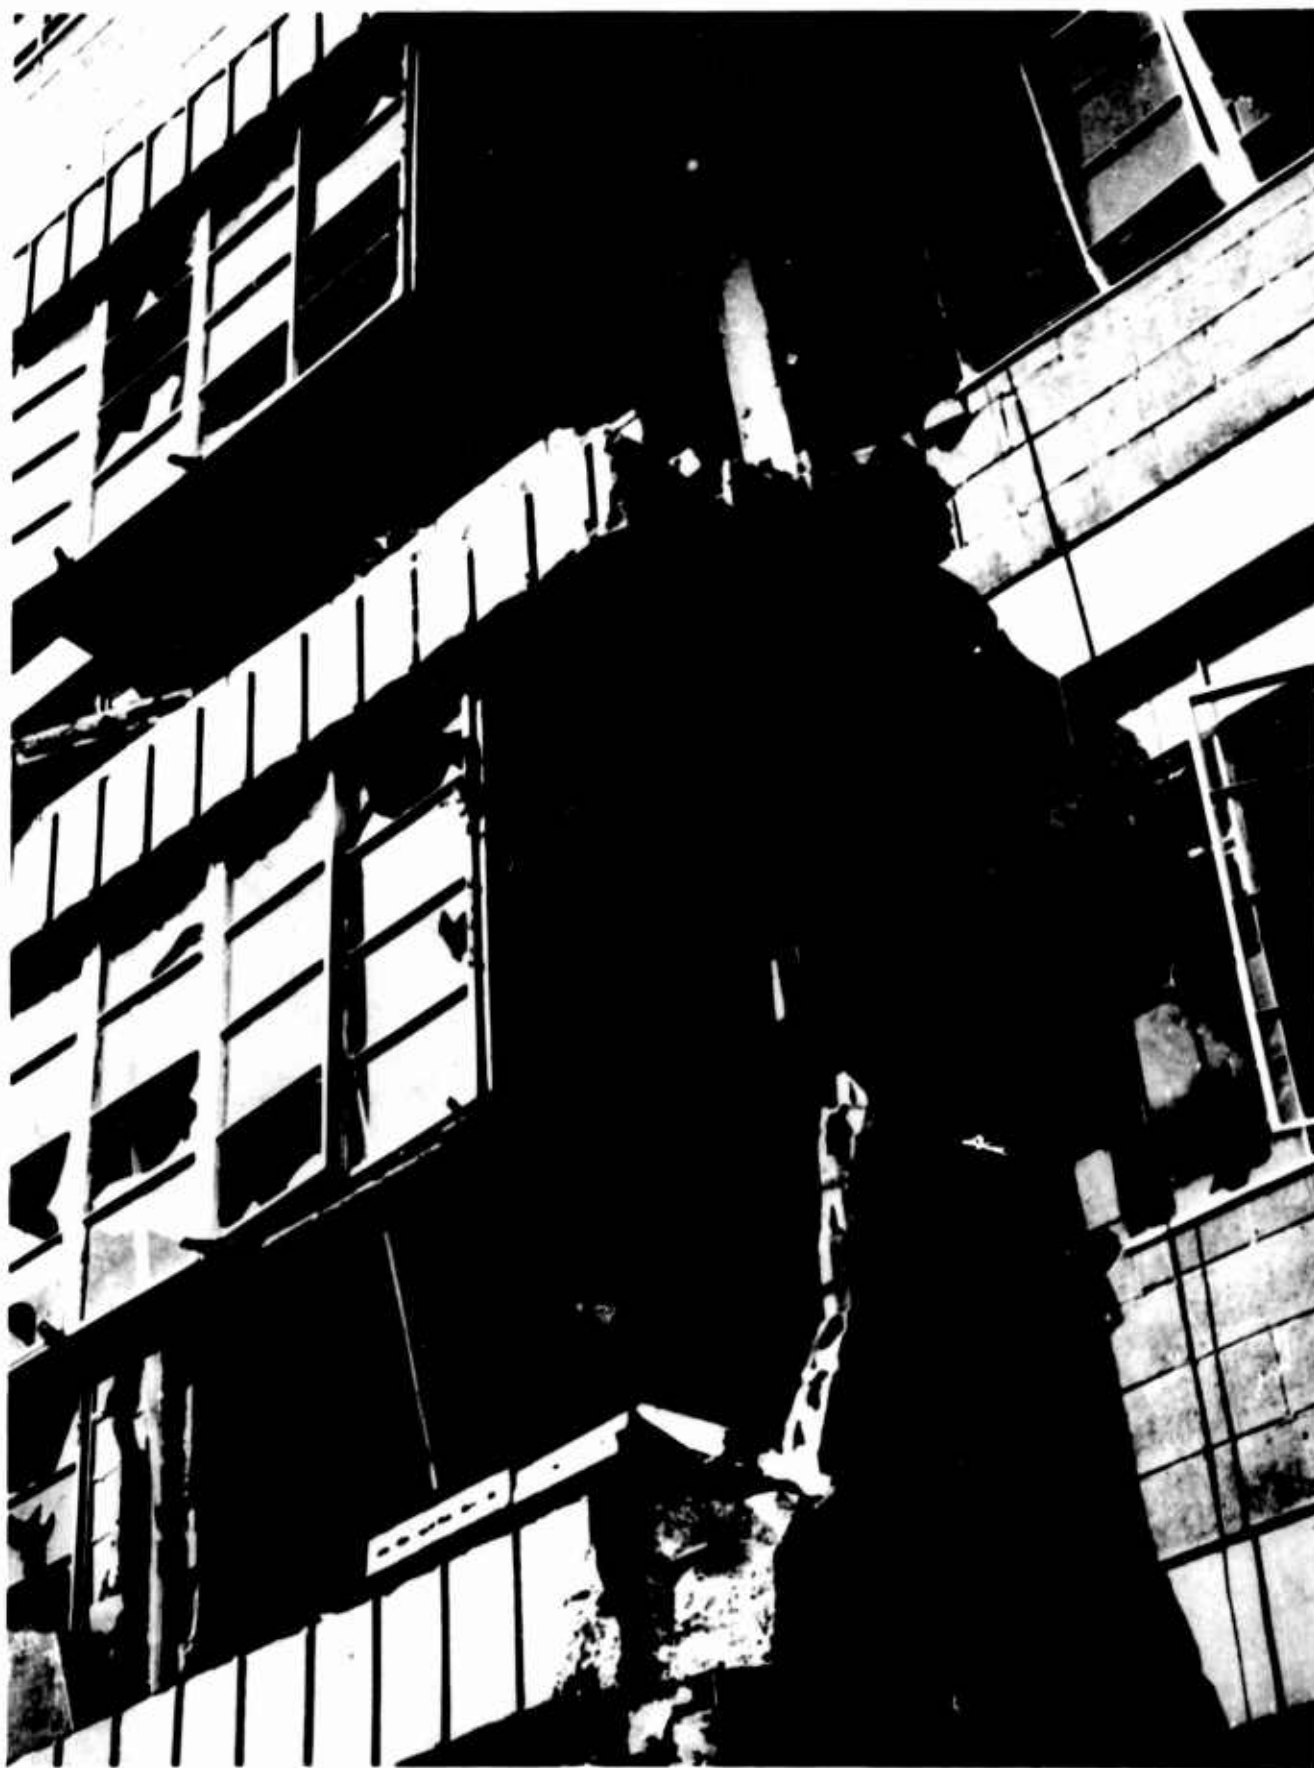
Figure 277. Hillside Apartments (Window frames in rear of building remain suspended from steel beams after masonry-block walls around them fell)

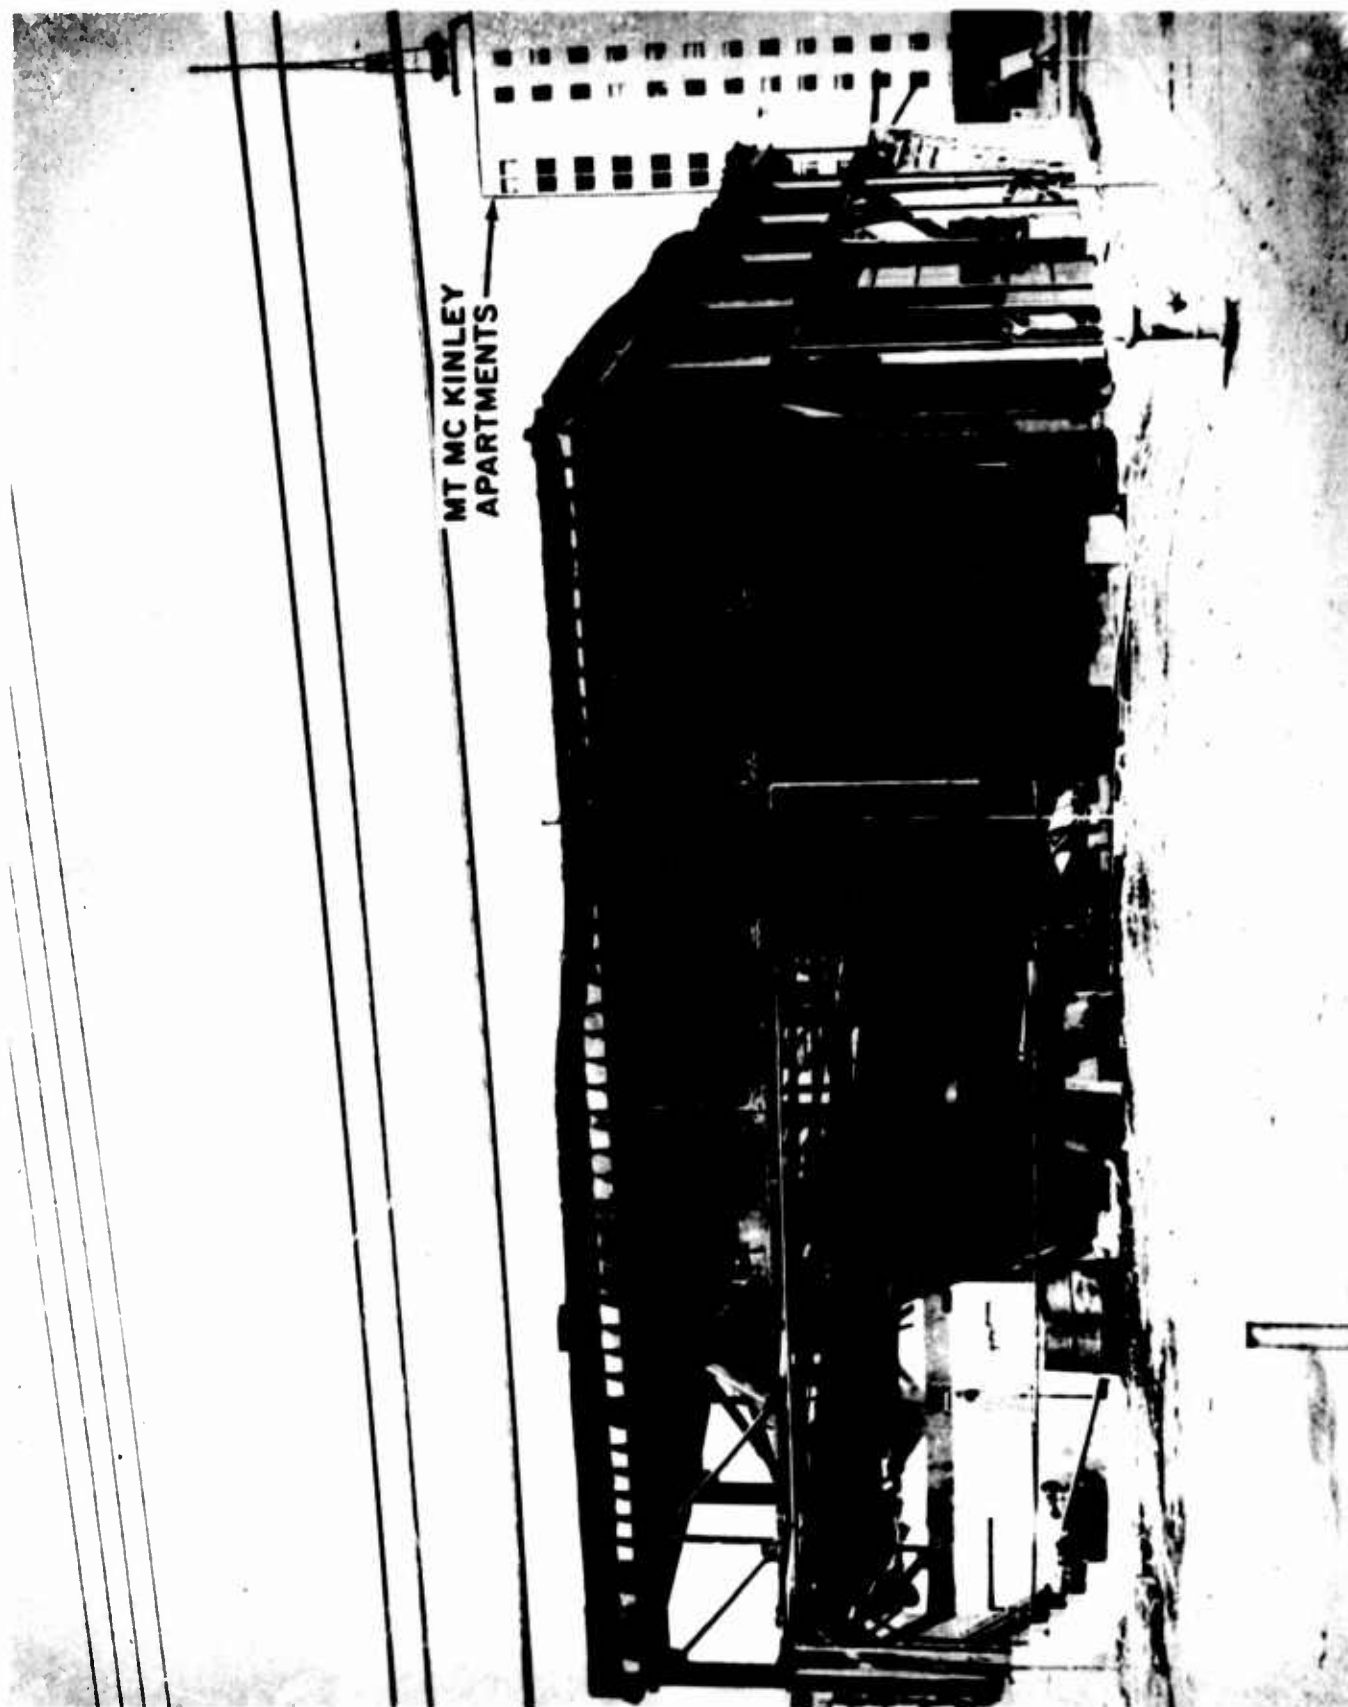
Figure 283. Wright Way Auto Carrier Garage
(South end of building showing its steel frame and a few remaining masonry blocks)

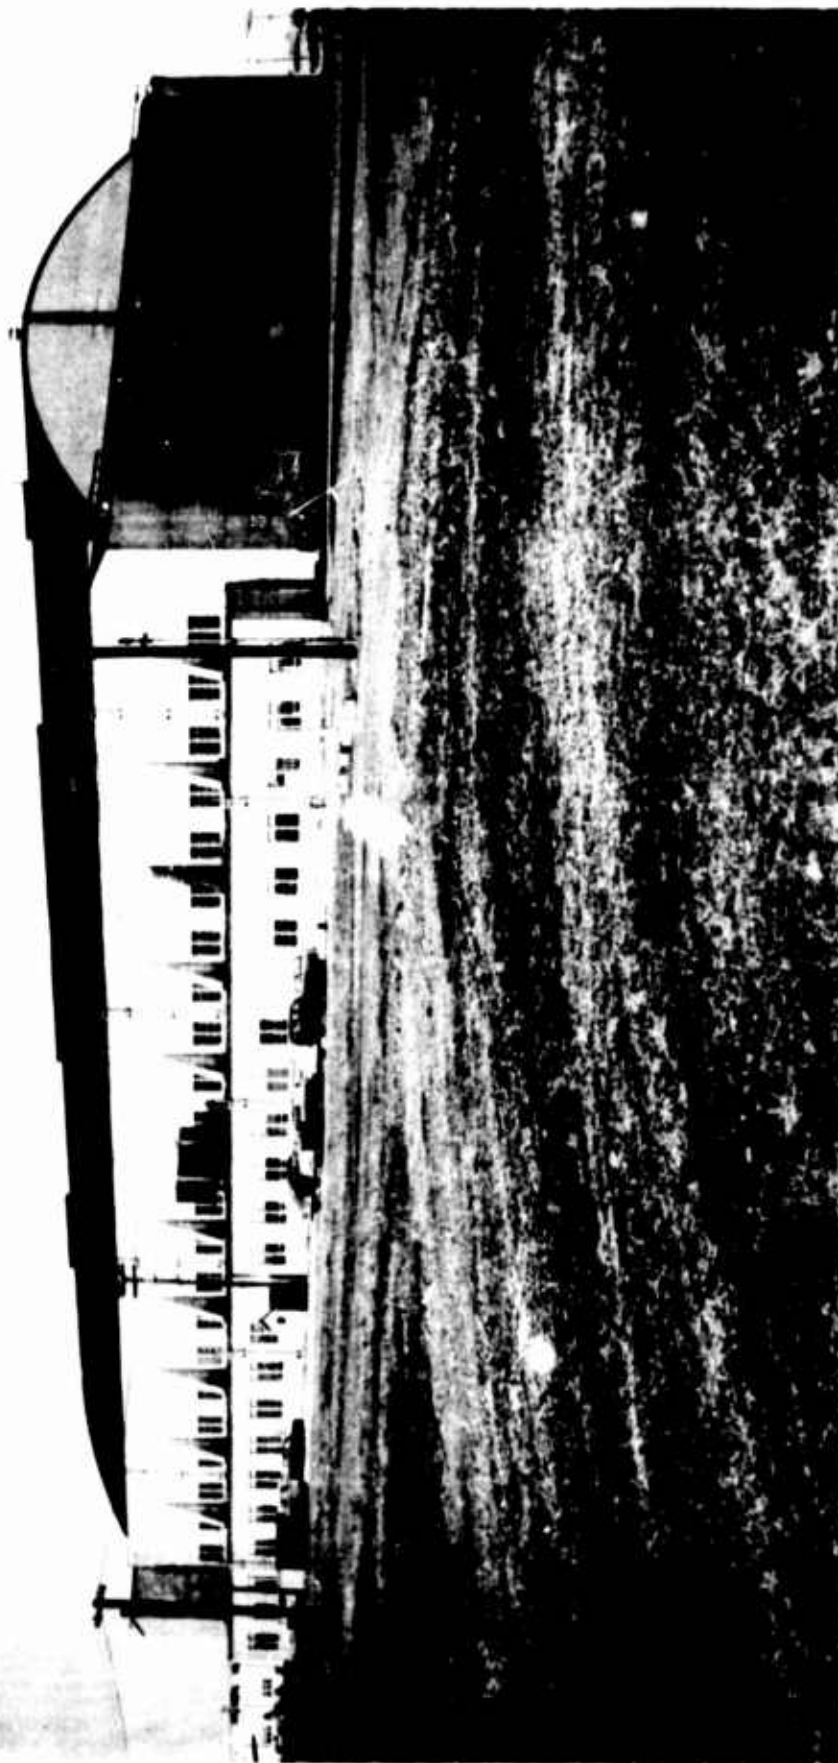
Figure 287. Elmendorf AFB Aircraft Maintenance Hangars
(South side of Building 32-060, one of two identical birchwood hangars)

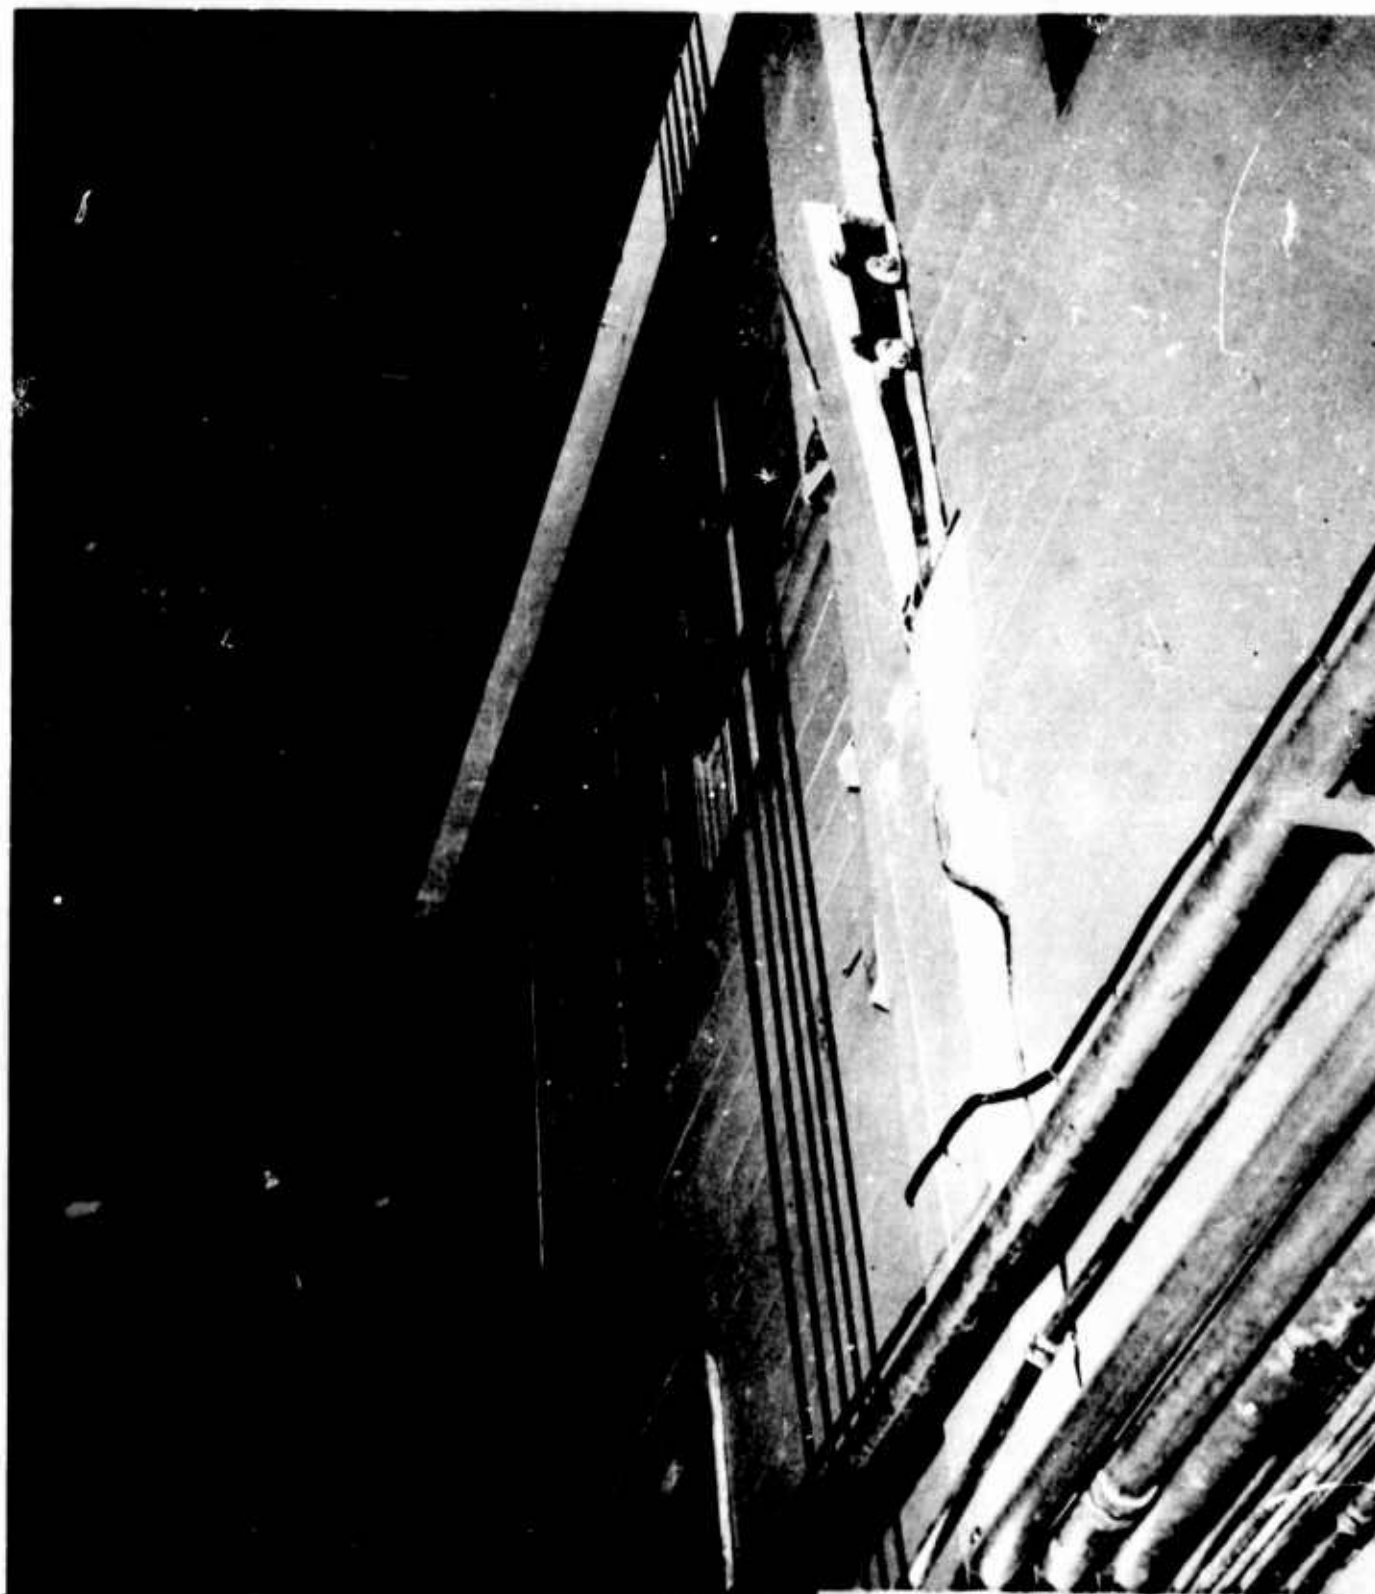
Figure 295. Elmendorf AFB Aircraft Maintenance Hangars
(Closeup of split vertical member at a splice)
